Home Check America Inspection Services

Confidential Inspection Report

Annulet Dr., Rockton, IL

9/23/2007

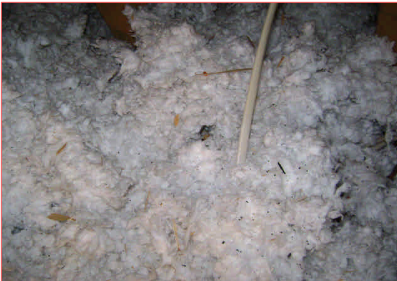
2.3 - The attic is contaminated by rodents, which is a significant health hazard, and should be evaluated by an exterminator as soon as possible. Rodents can compromise not only the attic and its various components, such as ducts and insulation, but can eventually compromise the living space as well. Consequently, we disclaim any further responsibility for evaluating the attic and its components.

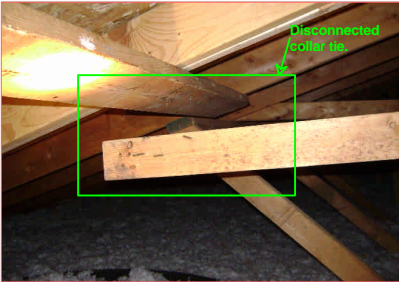
2.4 - Some of the collar-ties or sway braces are missing or damaged. This is not a serious structural deficiency, but one that should be reevaluated or serviced.

Some of the collar-ties or sway braces are missing or damaged - *Continued*

2.2 - Some of the collar-ties or sway braces are missing or damaged

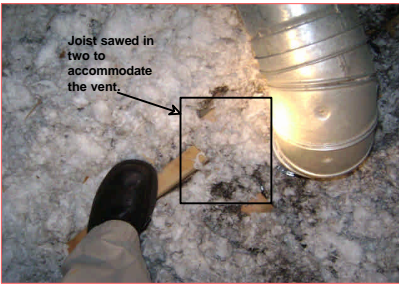
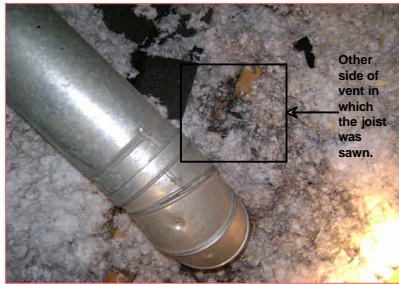
2.5 - One or more joists are either cracked, sawed off, or broken. This can affect the structure of the roof and lead to unwanted cracks in the walls. Recommend repair to the highest standards by a qualified contractor prior to closing.

2.3 - A joist is cracked sawed off or broken

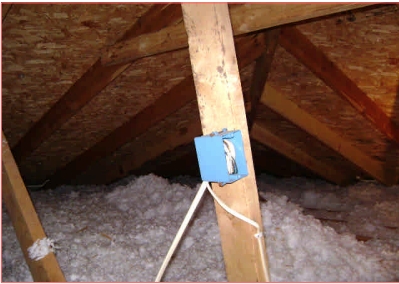
2.7 - There are open electrical junction boxes, which should be sealed to contain any arcing or sparking that might occur.

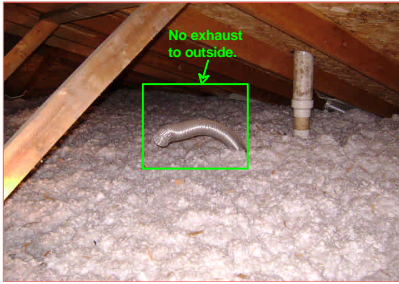
2.10 - The bathroom exhaust duct should be extended to an exterior vent port by a qualified contractor to the best standards prior to closing. If not repaired there is a possibility of mold developing in the attic.

The bathroom exhaust duct should be extended to an exterior vent port - *Continued*

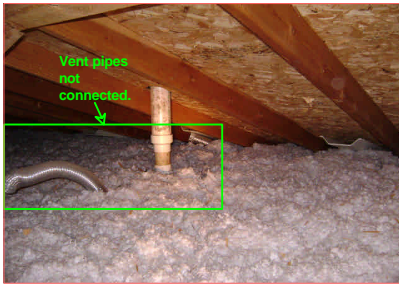
2.11 - The bathroom exhaust duct is separated, and should be repaired by a qualified contractor to the best standards prior to closing.

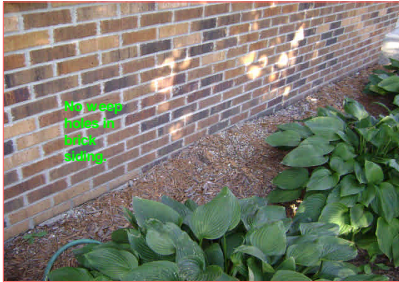
3.8 - Could not find weep holes in some areas of the brick veneer siding. Without the weep holes there is a chance for moisture to remain between the veneer and cladding and create conditions for mold and/or rotting of wood. Recommend a qualified contractor install weep holes in the brick veneer.

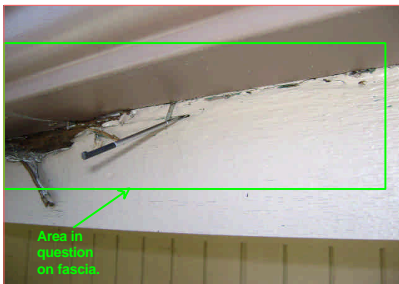
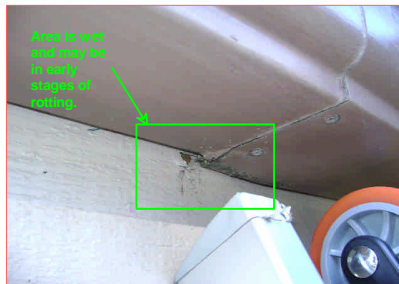
3.9 - All or portions of the fascia are rotting or damaged. Recommend a qualified contractor make the necessary repairs.

3.1 - Fascia is rotting or damaged

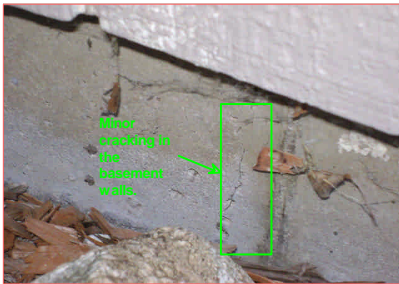
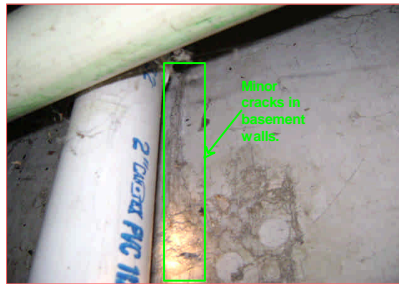
4.11 - There are some relatively small vertical cracks in the poured concrete walls, which are probably attributable to shrinkage and have little structural significance. Generally speaking, cracks that are less than 1/4" are not commonly regarded as being structurally significant. Nonetheless, they should be monitored to see if there is active movement in this area, because such cracks can become a contentious and litigious issue.

There are relatively small cracks in the foundation walls that should be monitored - *Continued*

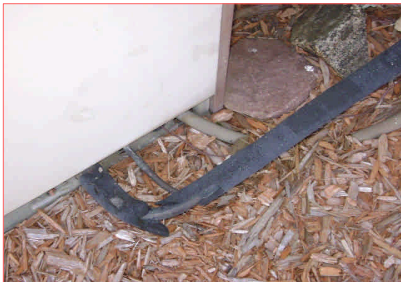
7.13 - Insulation is missing from the refrigerant lines at the exterior coil, which will allow condensation to form and drip, and should be installed.

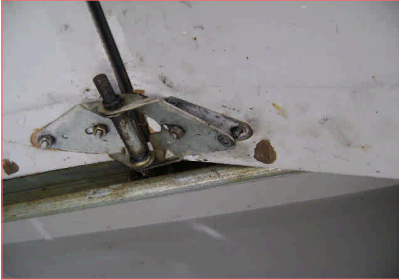
12.2 - The garage door hardware needs to be adjusted, so that the door is squarely aligned in its opening.

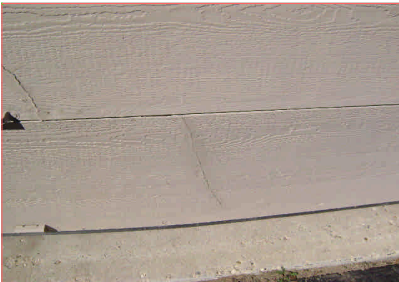
12.3 - There are one or more cracks in the lower panels that could affect operation of the door. Recommend repair/replacement of the tow panels.

18.2 - Cracks in overhead door
